Thickness measurements by UAV

De Challenge

De Solution

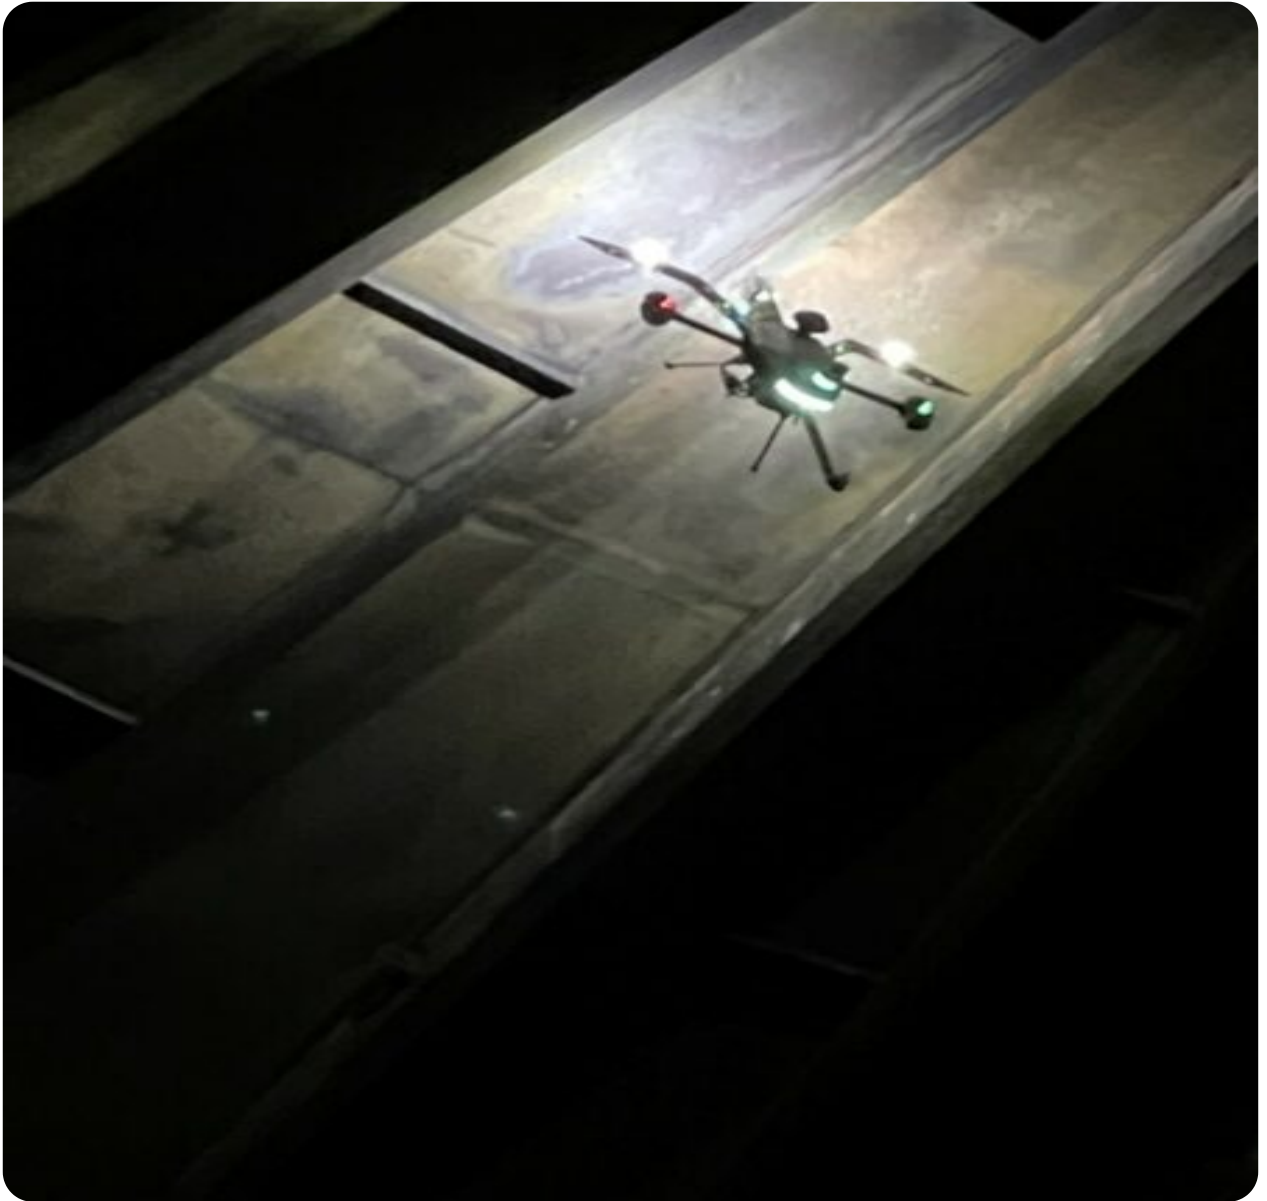
The Voliro drone is capable to fly indoor and bring the thickness measurement sensor (either UT or EMAT) to the challenging locations, and press the sensor under each angle to the wall, taking a proper and reliable wall thickness measurement reading. Our proper trained pilots work together with several well recognized and level II certified NDT- engineers.
