# Thickness measurements by UAV

## De Challenge

Determination of wall thickness of assets at heights which are hard to reach, require removal of insulation material and relatively riskfull rope access teams

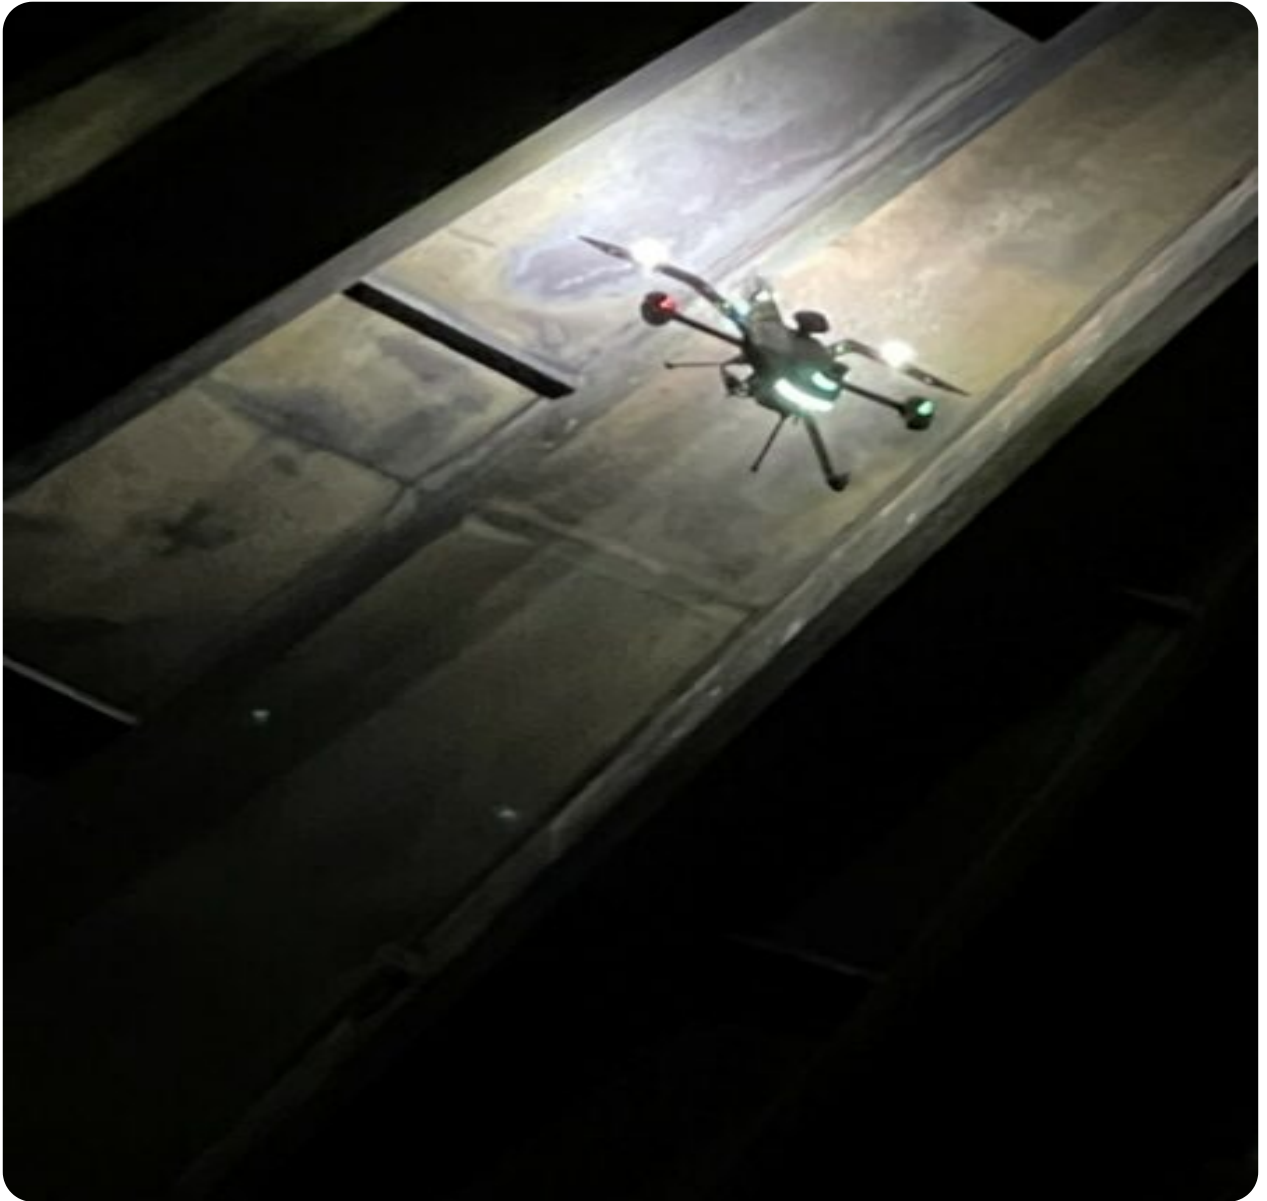
The Voliro drone is capable to fly indoor and bring the thickness measurement sensor (either UT or EMAT) to the challenging locations, and press the sensor under each angle to the wall, taking a proper and reliable wall thickness measurement reading. Our proper trained pilots work together with several well recognized and level II certified NDT- engineers.
